## Recent Local Sea Level Changes and its Impact on Geo-Environment of Purba Medinipur Coast, WB-A Geographical Analysis

Pranab Sahoo<sup>1</sup>, Subhankar Patra<sup>2</sup> And Jitendra Shukla<sup>2</sup>

<sup>1</sup>Department of Geography, Seva-Bharati Mahavidyalaya, Paschim Medinipur,

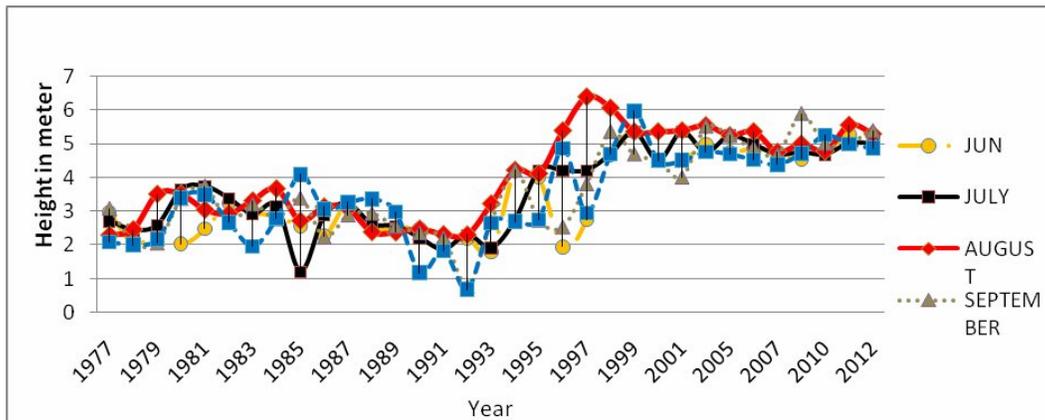
Fig. 2 : Variation of highest sea gauge during 1976-2012

last 30 years along Digha-Mandarmoni coastal tract. By the calculating of seasonal sea gauge especially monsoon, it is observed about 2.5m to 5.3m increasing during the last 30 years (Figure-2). The deltaic setting, human intervention, supply of sediments, forming of offshore bar, basement faulting, tectonically very active have also very significant for the local sea level rise, as well as global warming over the last 3 decades. The analysis of remote sensing, sea gauge data and field data of the past 3 decades indicates an increasing local sea level rise at a remarkable rate of 15cm/last 3 decades.

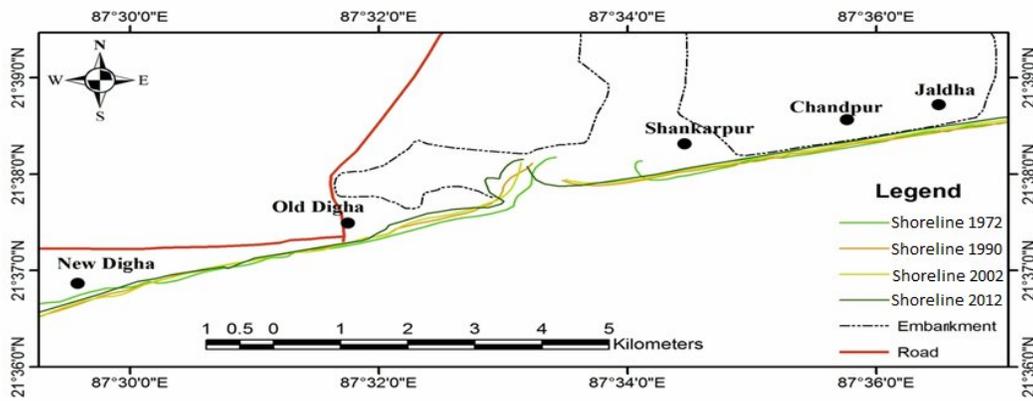
Fig.3 : Shoreline shifting 1972 to 2012 derived from SOI toposheet and satellite imagery

The rate of landward shifting of shoreline has been estimated by studying beach profiles and by interpretation of survey of India (SOI) toposheet, satellite images. From the recorded data and comparative study with survey of India toposheet, satellite images and field data it is found that during 1972-2012 the eastern part of this coastal tract from Digha estuary to Jaldah estuary about 13km was under prominent erosion and landward shifting of shoreline (Chatterjee, 1972). However Jatranala to new Digha about 1km length has under little accretion this period (Figure-3, and figure- 4a, 4b).

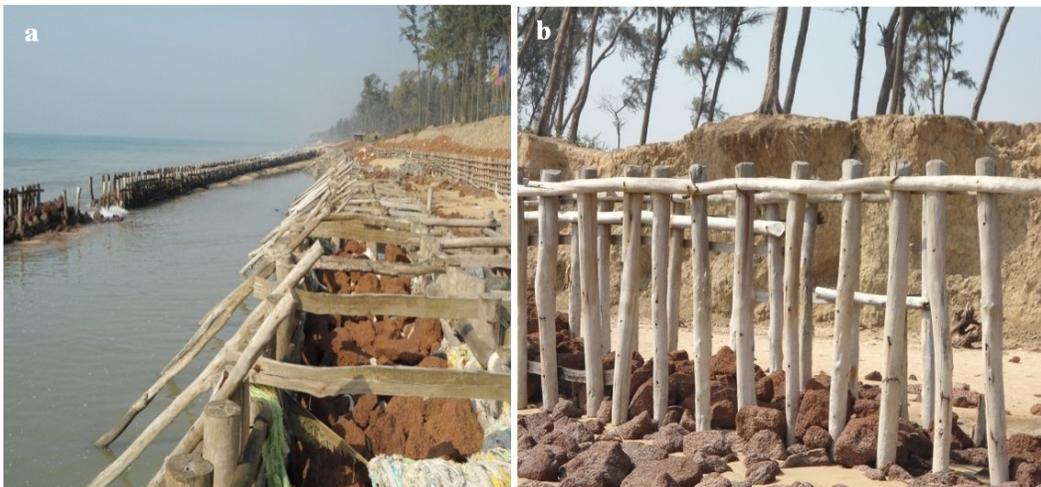
Fig. 4 : (a) landward shifting of shoreline and high tidal mark and (b) Existing damaged sea dyke of Chandpur-Jaldha sector

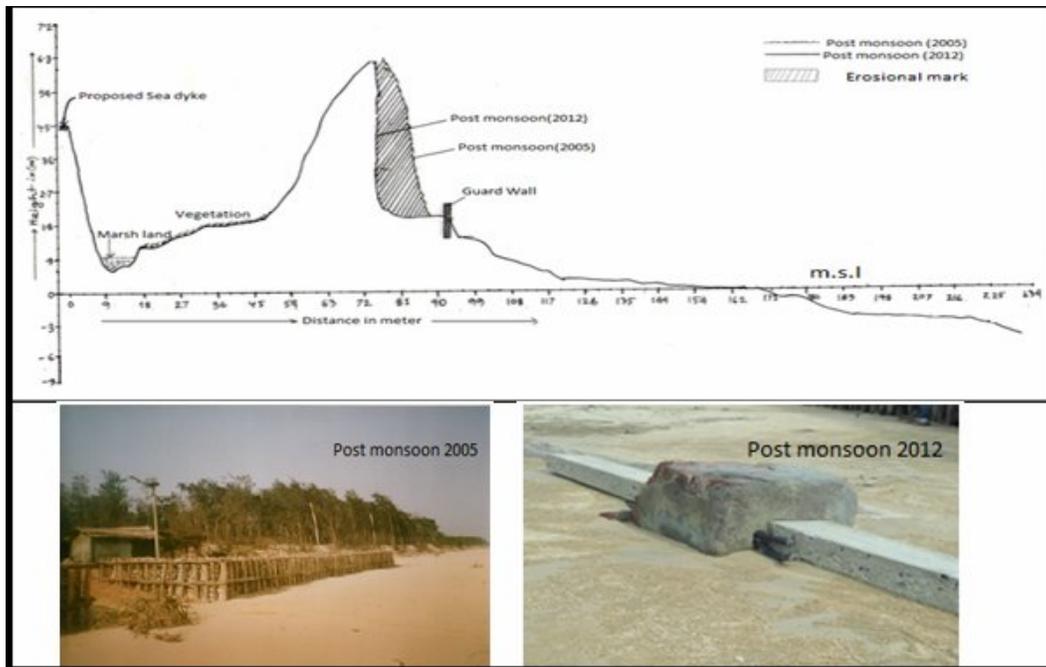
Fig. 5 : Wider active profile of the monsoonal season are always increasing shoreline with the local sea level rise at Shankarpur, Chandpur.

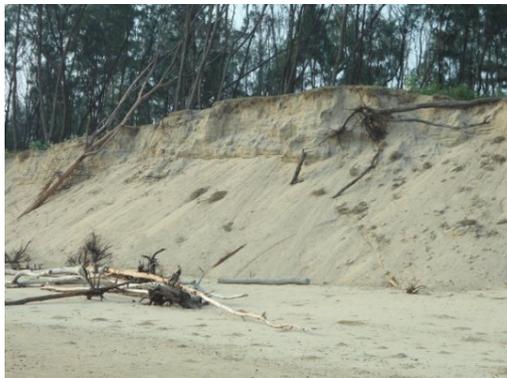
Fig. 6 : Recession of dune crest at Ghangadharpur to Shankarpur

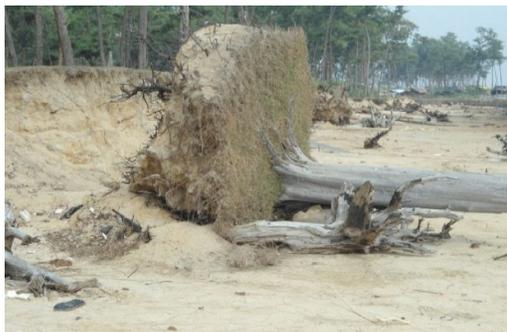
Fig. 7 : Uprooted Casuarina trees from the shore front dune barrier at Shankarpur

Recent physiographic changes due to sea level change around Digha to mandarmoni coast is recorded through maps, charts, air photograph, satellite imagery, field investigation and others records since 1977 in this coastal tract. Physiographic change of foredunes include: dune flattening, wash over dune breaches, cliff formation, crest recession (figure-6), dune erosion of sea face, variation of dune height (Table-5) and complete removal or elimination of dune bodies are most significance environmental impact type to coastal area at Shankarpur, Chandpur. Wider active profile of the monsoonal season are always increasing shoreline with the local sea level rise (Figure-5). Casuarinas trees are uprooted from the front dune barrier and a large part of mangrove forest is also lost by erosional activity (figure 7).

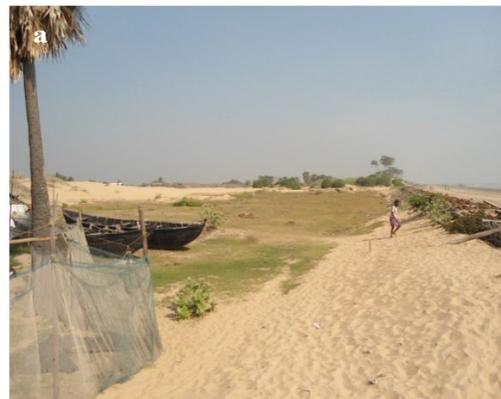
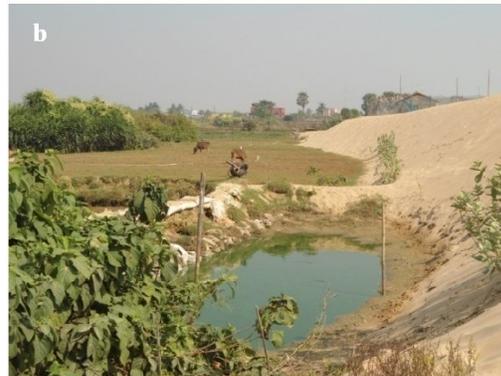
Fig. 8 : Accelerated shifting of sand dunes to landward and also capture the agriculture land, fishing pond at Shankarpur.

remind very dynamic during the last century especially last 30 years, which influences the ecology and human society (Table 7). Accelerated shifting of sand dunes to landward and also capture the agriculture land, fishing pond at Shankarpur (Table 6 and figure 8).

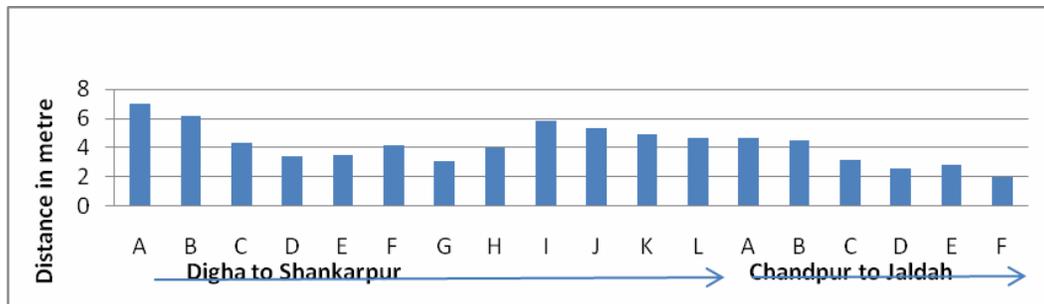
Fig. 9 : Rate of coastal erosion in recent year at various places

Prominent land ward encloement of dune along with the shoreline changes strongly support that local sea level rise is now alarming stage in this area. Shifting of shoreline, coastal erosion (Table 8 and Figure 9), narrowing sea beach and shifting of sand dunes are severe problem of this area and also remarkable change of geo-environment. Human intervention, particular over the last 30 years has also been very significant for the change in coastal geo environment. Construction of fishing harbour, covering a large area
